The SAN DIMAS EXPERIMENTAL FOREST

Lawrence W. Hill

Pacific Southwest Forest and Range
Experiment Station - Berkeley, California
Forest Service - U. S. Department of Agriculture

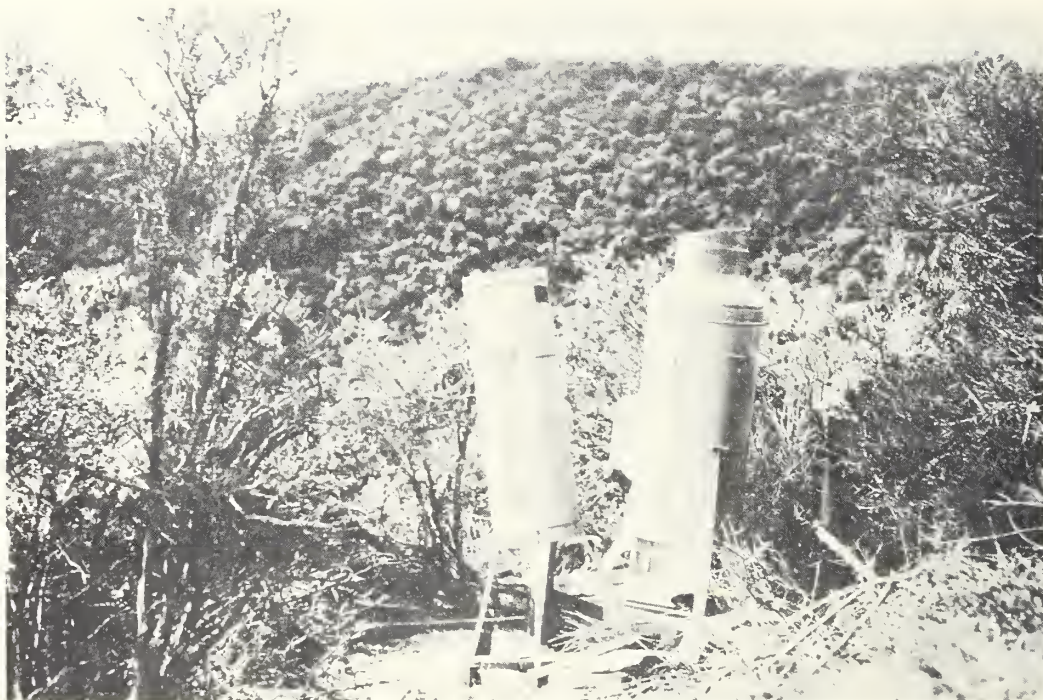
Figure 2.--More accurate measurements of rainfall result when storage gages are tilted (left) and recording gages are fitted with "stereo" funnels (right).

One of our first tasks was to learn when rain occurs, how much, and how intensely. We soon found that conventional vertical raingages gave inaccurate rainfall measurements. They were especially inaccurate during high intensity storms when accurate measurements were most needed (fig. 1). After testing raingages of many sizes and shapes, we found that if the receiving rim of the gage were parallel to the mountain slope upon which it is placed, the measurements were much more accurate. Now storage gages are tilted, and recording gages, which must stand vertical, are fitted with funnels cut parallel to the slope (fig. 2). This permits reliable records with much fewer raingages. To meet the needs of expanded research we now sample rainfall with a network of 115 raingages. Most of them are concentrated in special research areas.

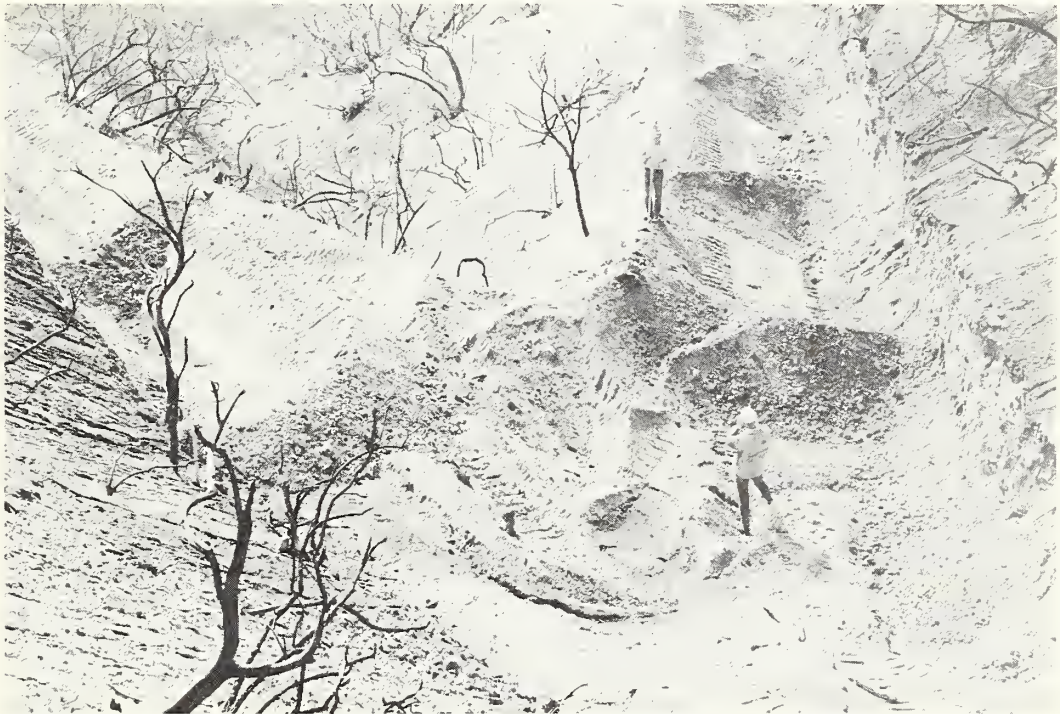
Figure 8.--Completed trench. The basins hold runoff and lessen the lateral movement of water within the trench.

Large permanent trenches (terraces) were constructed in nine of the watersheds (fig. 8). This practice was developed in the Intermountain Region of the Forest Service. The trenches were constructed with a heavy bulldozer and were spaced on contour 40 to 90 feet (12.2 to 27.4 meters) apart, depending on slope. A completed trench system provides dead storage for a storm that produces 3 inches of rain (76.2 mm.) or for 550 cubic yards of sediment per acre (420.5 cubic meters per .405 hectares).

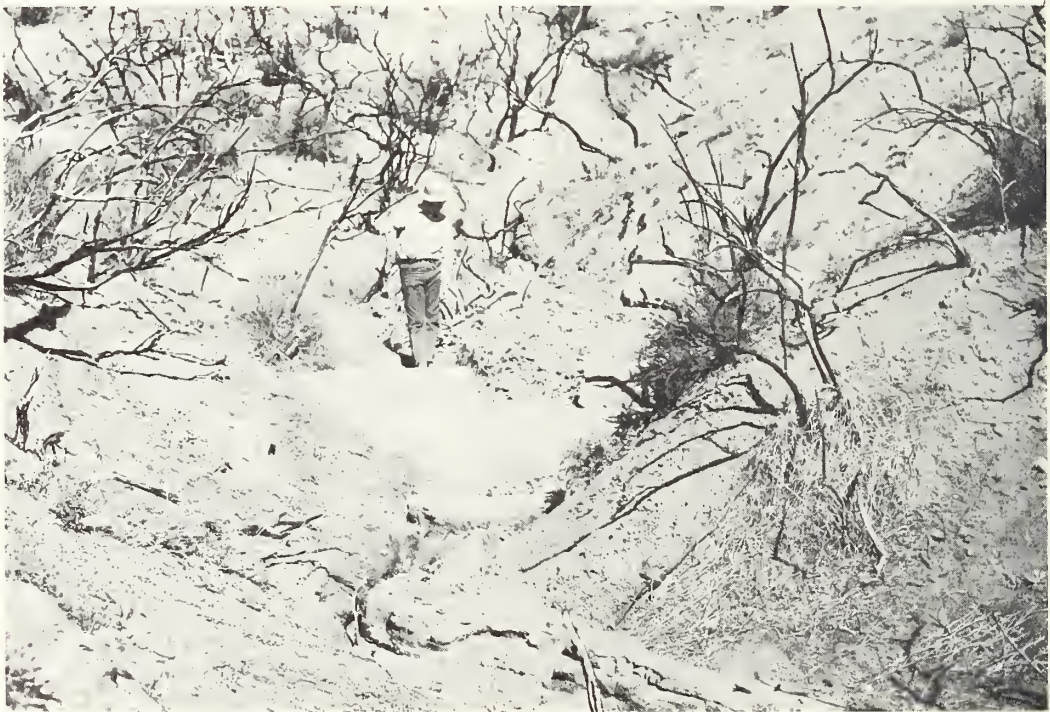
Figure 9.--Stream channel checks. Their purpose is to prevent channel downcutting and to stabilize canyon side slopes.

Small dams were constructed of cement combined with soil and rock available at the dam sites in nine of the watersheds (fig. 9). The purpose of these dams is to prevent channel downcutting, to stabilize side slope soils, and to spread out streamflow and thus reduce its velocity and erosive power.

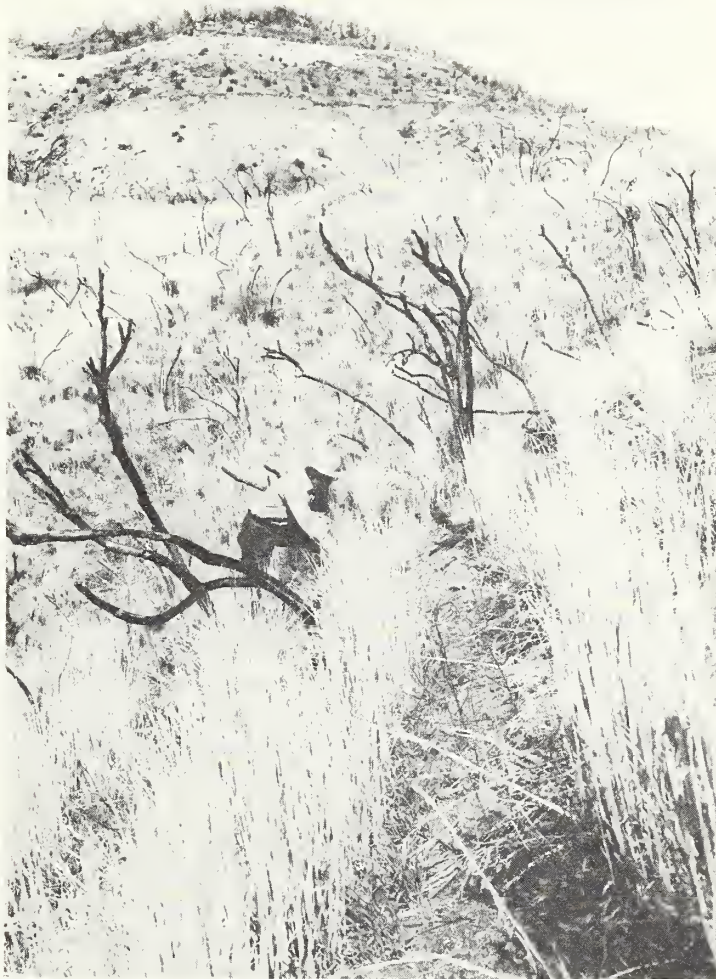
Figure 10.--Contour row planting of barley.
Barley impedes overland flow of water and
sediment.

Barley seed and fertilizer were placed in furrows in nine small watersheds to form dense rows on 2-foot (.61 meters) contour intervals (fig. 10). Barley (Hordeum vulgare var. Atlas) was chosen because it grows more vigorously than most species during cool winter weather. The fertilizer was included to promote earlier and heavier growth. The purpose of this treatment is to impede overland flow of water and sediment on side slopes.

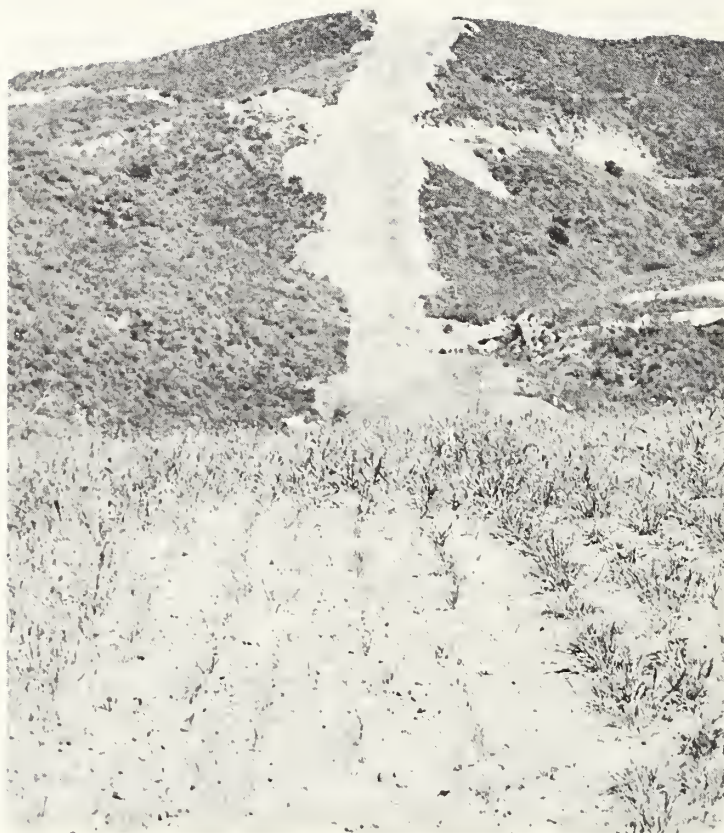
Figure 11.--A ridge-top fuel-break. Dense brush fields are broken into manageable blocks of fuels by these wide strips which support light-volume fuels, such as grass.

Firefighting agencies and researchers are trying a new approach: to modify fuel conditions by breaking the expanses of brush into smaller units. Modification is done by converting the dense brush to a cover of light-volume fuel, such as grass, on wide strips or blocks of strategically located land. These converted areas are called fuel-breaks (fig. 11).
